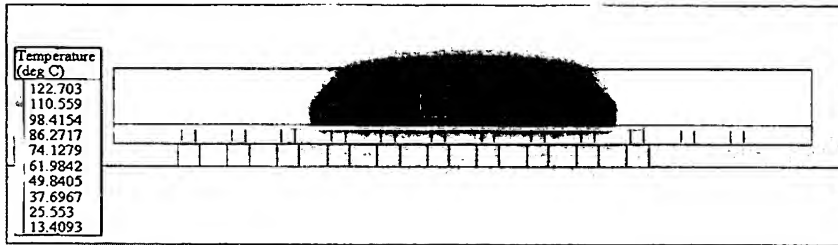
1010

1. Reference, normal design:

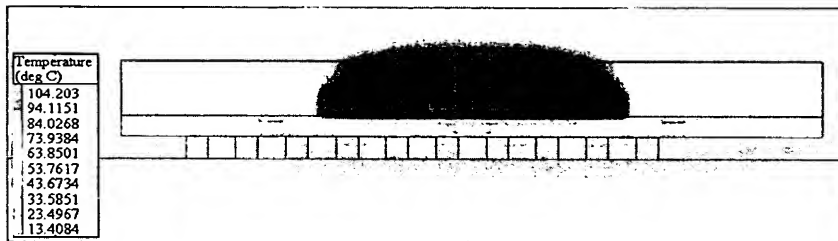
1020

2. Enhanced design, top and bottom thermal fingers:

~ 15 % thermal performance decrease in package level

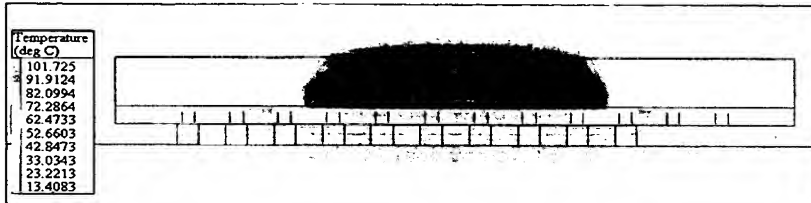
1030

3. Enhanced design, top and bottom thermal fingers + thermal vias:

~ 17 % thermal performance decrease in package level

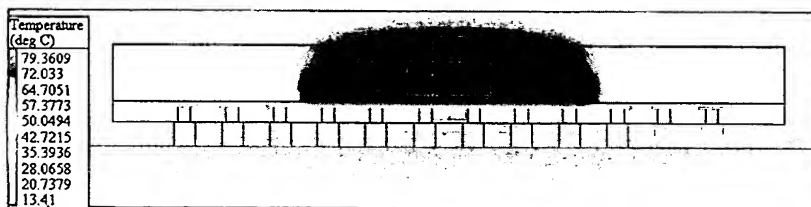
1040

4. Enhanced design, top thermal fingers and bottom net + vias:

~ 35 % thermal performance decrease in package level
